UNITED STATES ENVIRONMENTAL PROTECTION AGENCY

Facility Name: Formosa Plastics Corporation, Inc.

RCRA CORRECTIVE ACTION INSPECTION REPORT

FORMOSA PLASTICS CORPORATION

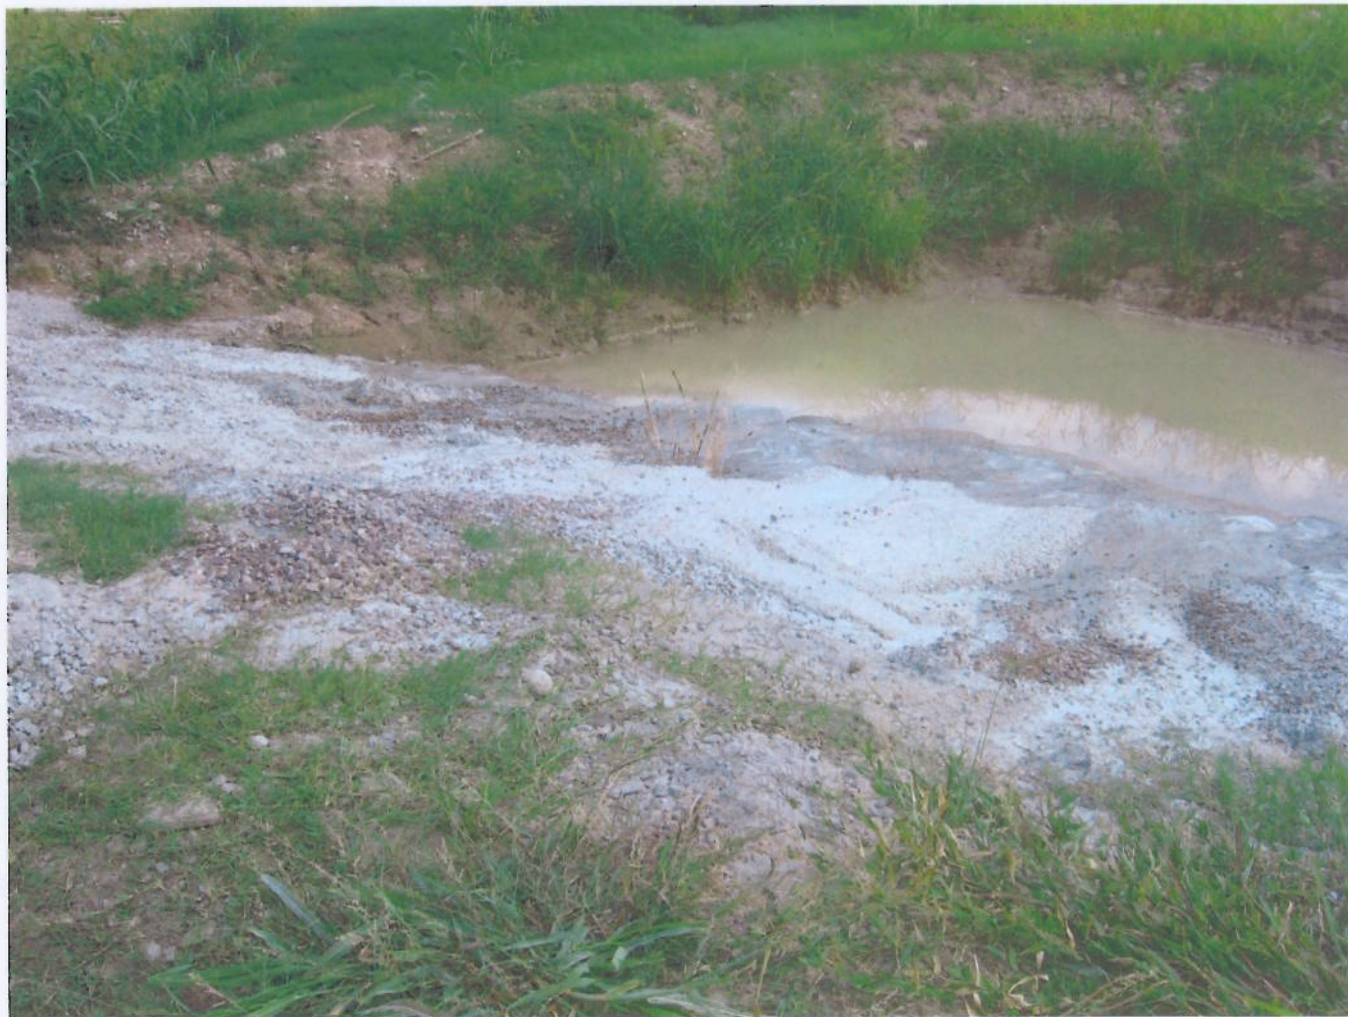
Official Photograph Log
Photo No. 1

1. AOC 2 is the construction Soil Pile, located northeast of the new Specialty Poly Vinyl Chloride (SPVC) Plant. According to Mr. Brogger, the Soil Pile was started approximately 2009 and was estimated to be approximately 4 acres in size. The soil came from the construction area for the SPVC Plant. The Soil Pile contained concrete and soil debris. A concrete washout pond was observed (see Attachment B, Photograph 1). According to Mr. Brogger, once the concrete has hardened, it is removed from the pond and placed on the Soil Pile. Formosa plans to hire a concrete crusher to crush the concrete rubble and re-use the crushed concrete for road base and riprap. Formosa has established a second soil pile located approximately 200 feet south of AOC 2 for storage of soils removed from the construction area for the new Frac II expansion project.

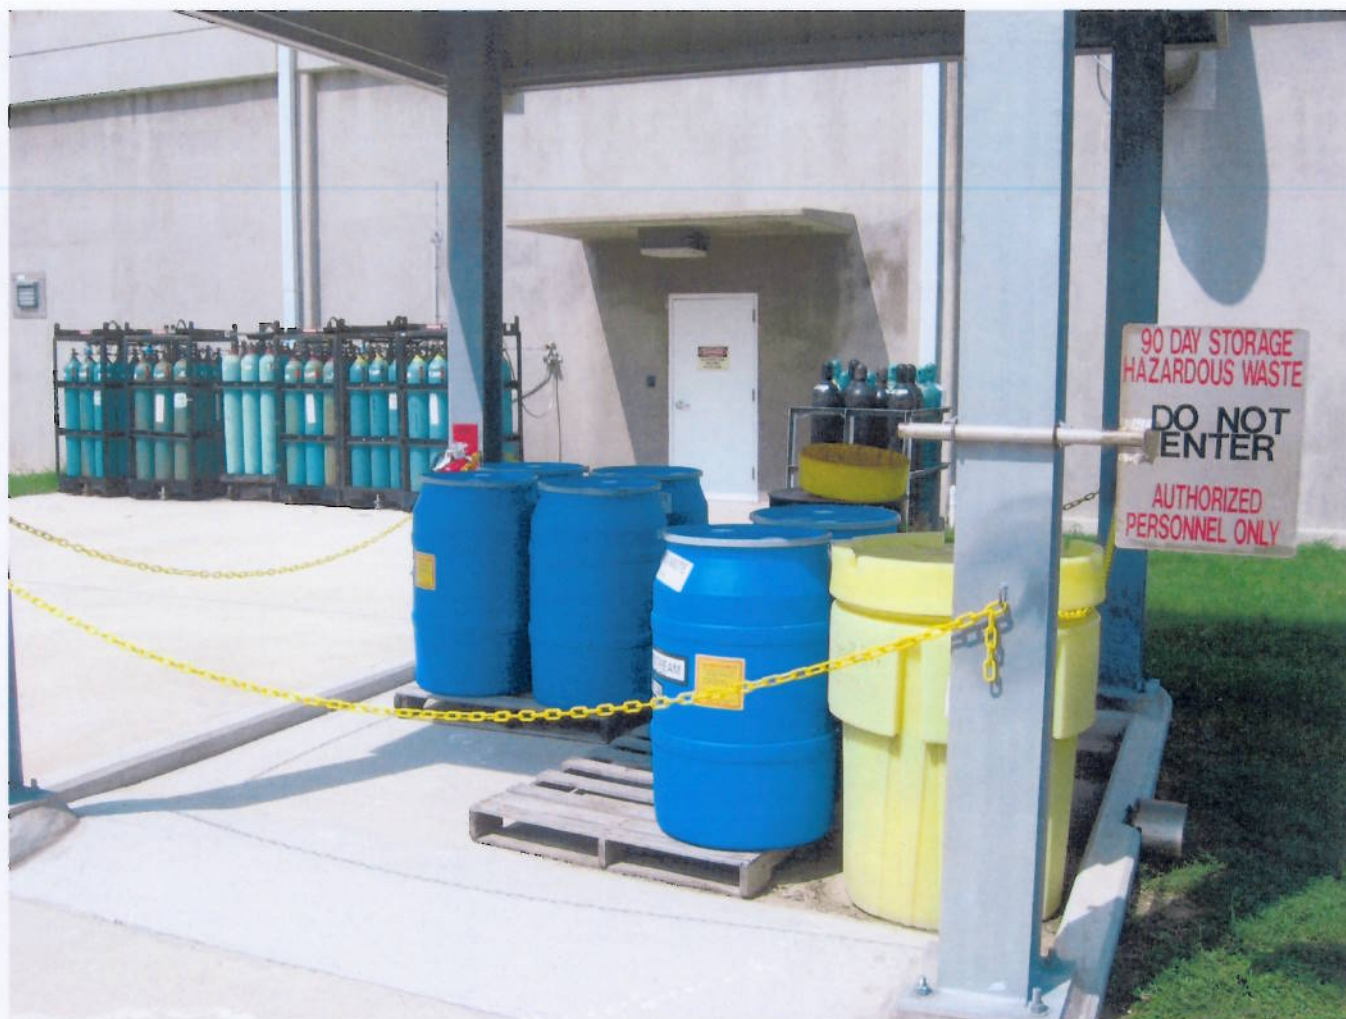
Official Photograph Log
Photo No. 2

2. SWMU 11 is a Container Storage Areas at the SPVC plant area. SWMU 11 is a less than 90 day storage area (see Attachment B, Photograph 2). At the time of inspection, there were 7 drums and 1 spill kit stored in the area.

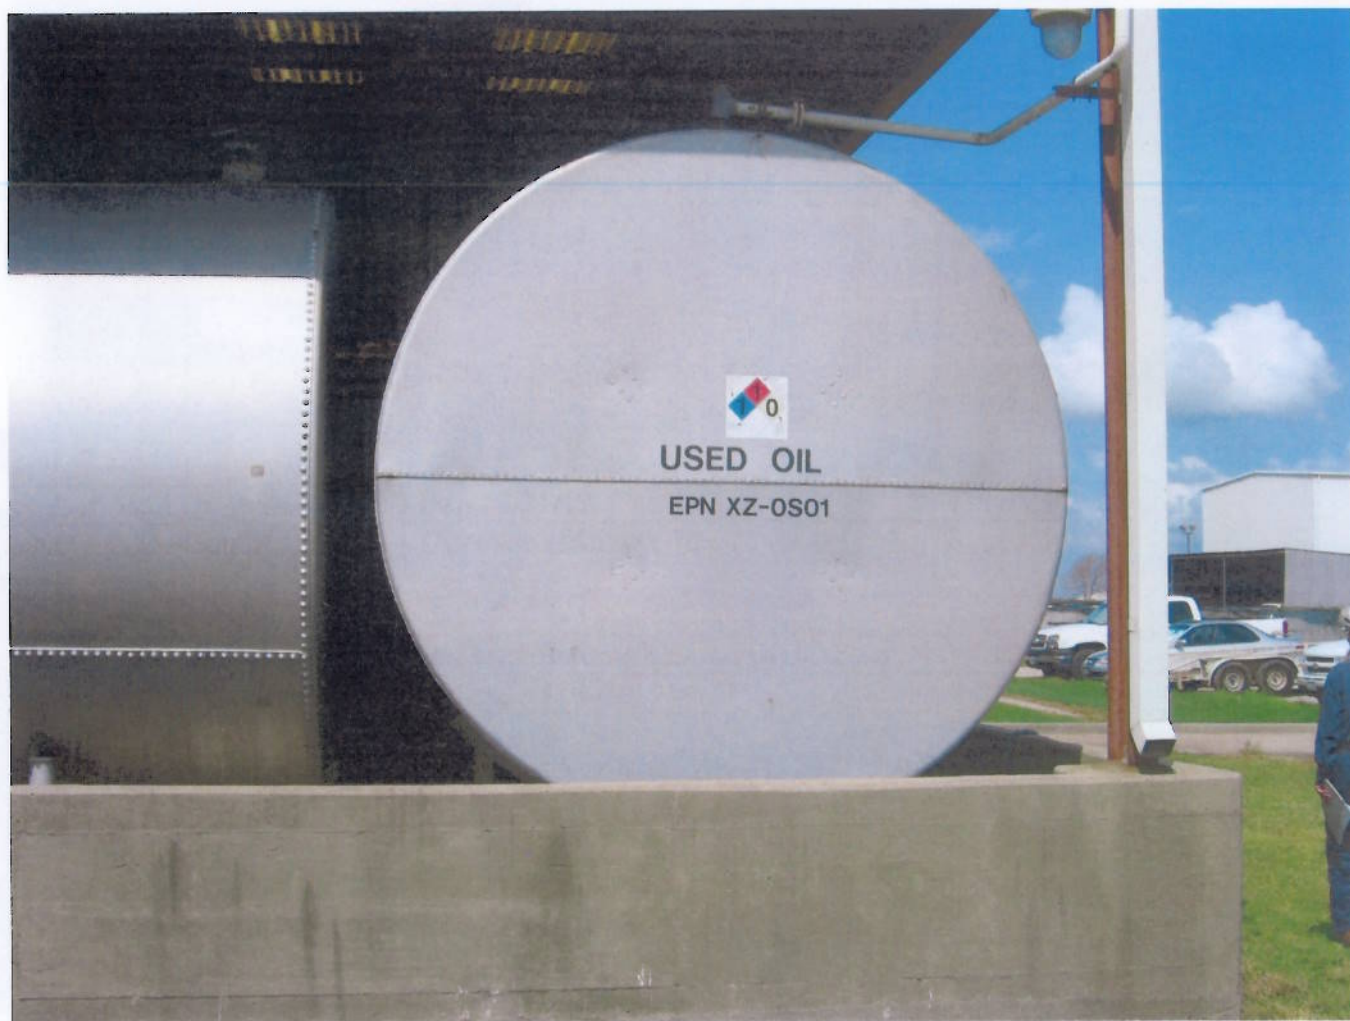
Photo No. 3

4. AOC 6 included the Used Oil Storage Tank, Wash Pad, and Oil Water Separator in the Central Maintenance Area.
 - a. The Used Oil Tank is an approximate 25,000 gallon steel tank located within a concrete-bermed secondary containment structure. The containment structure has a roof, which restricts the amount of precipitation entering the structure, and is open on three sides (see Attachment B, Photograph 3).

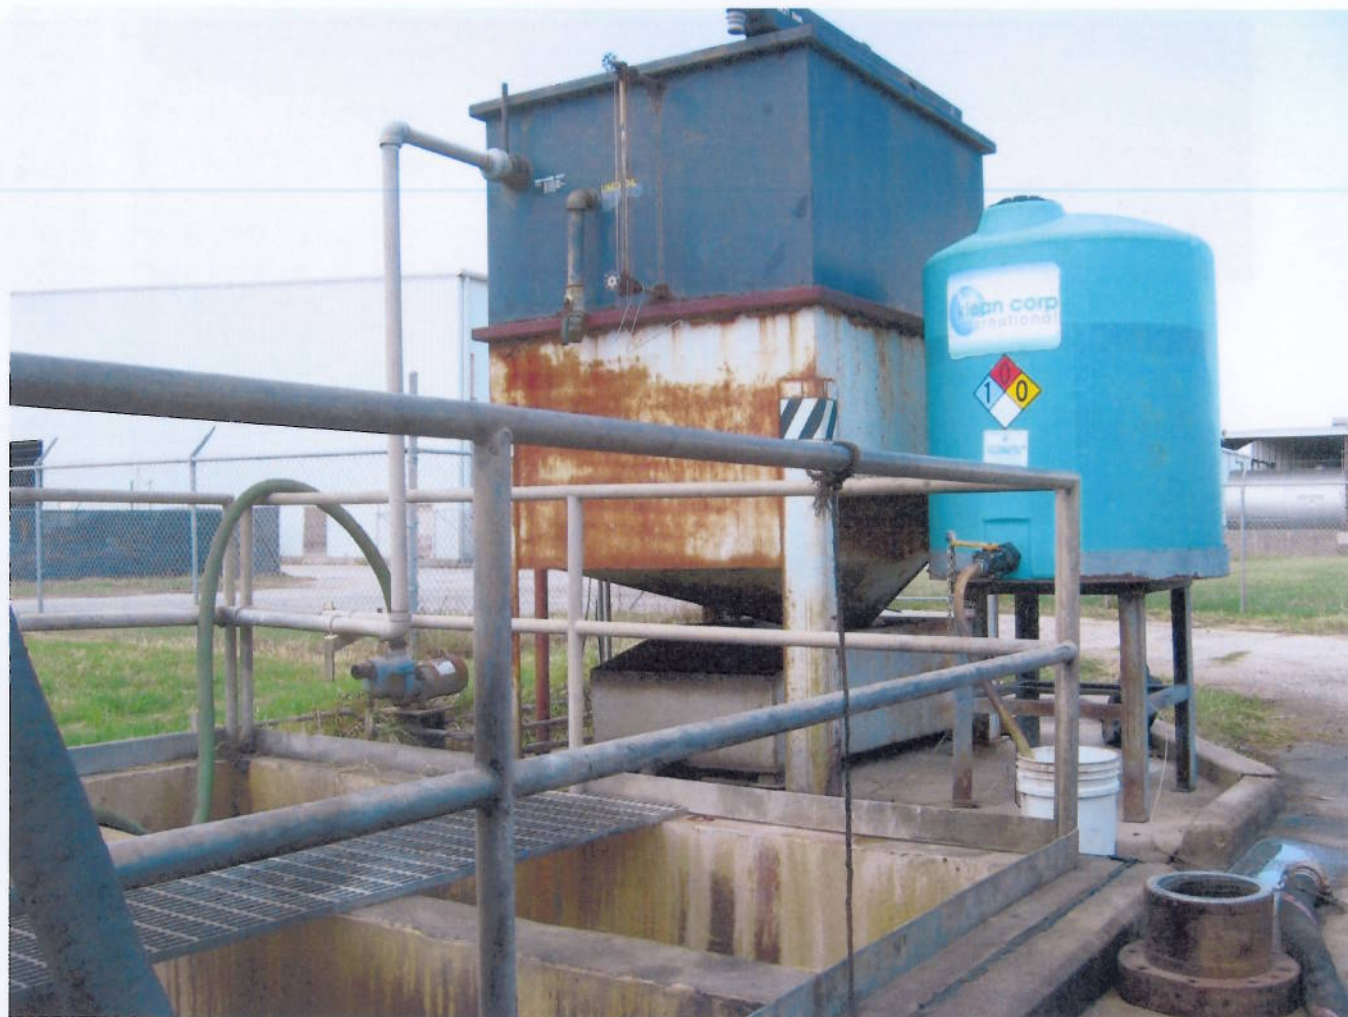
Official Photograph Log
Photo No. 4

- b. The Wash Pad is a concrete drive that has approximately 3-inch ramped berms on three side and the approximately 6-inch, raised concrete edge of the oil water separator to capture any leaks or drips during transfer of oily wastewaters to the oil-water separator (see Attachment B, Photograph 4).

vacuum truck and transported to the Central Wastewater Treatment Plant for treatment. Used oil is skimmed from the surface by vacuum truck and stored in the Used Oil Tank. EPA requested information about the frequency and quantity of oil removed from the Oil Water Separator (see Attachment B, Photograph 4).

At the time of inspection, EPA noted an area of concern of stained soil in a drainage path flowing from the Wash Pad outside of the bermed area along the southwest corner of Wash Pad.

| 6 | Discharges onto the pad? | At the time of the inspection, a discolored area (appeared to be used oil) was observed outside the bermed area of the wash down pad. Area was approximately 6 inches wide by 3 feet long |

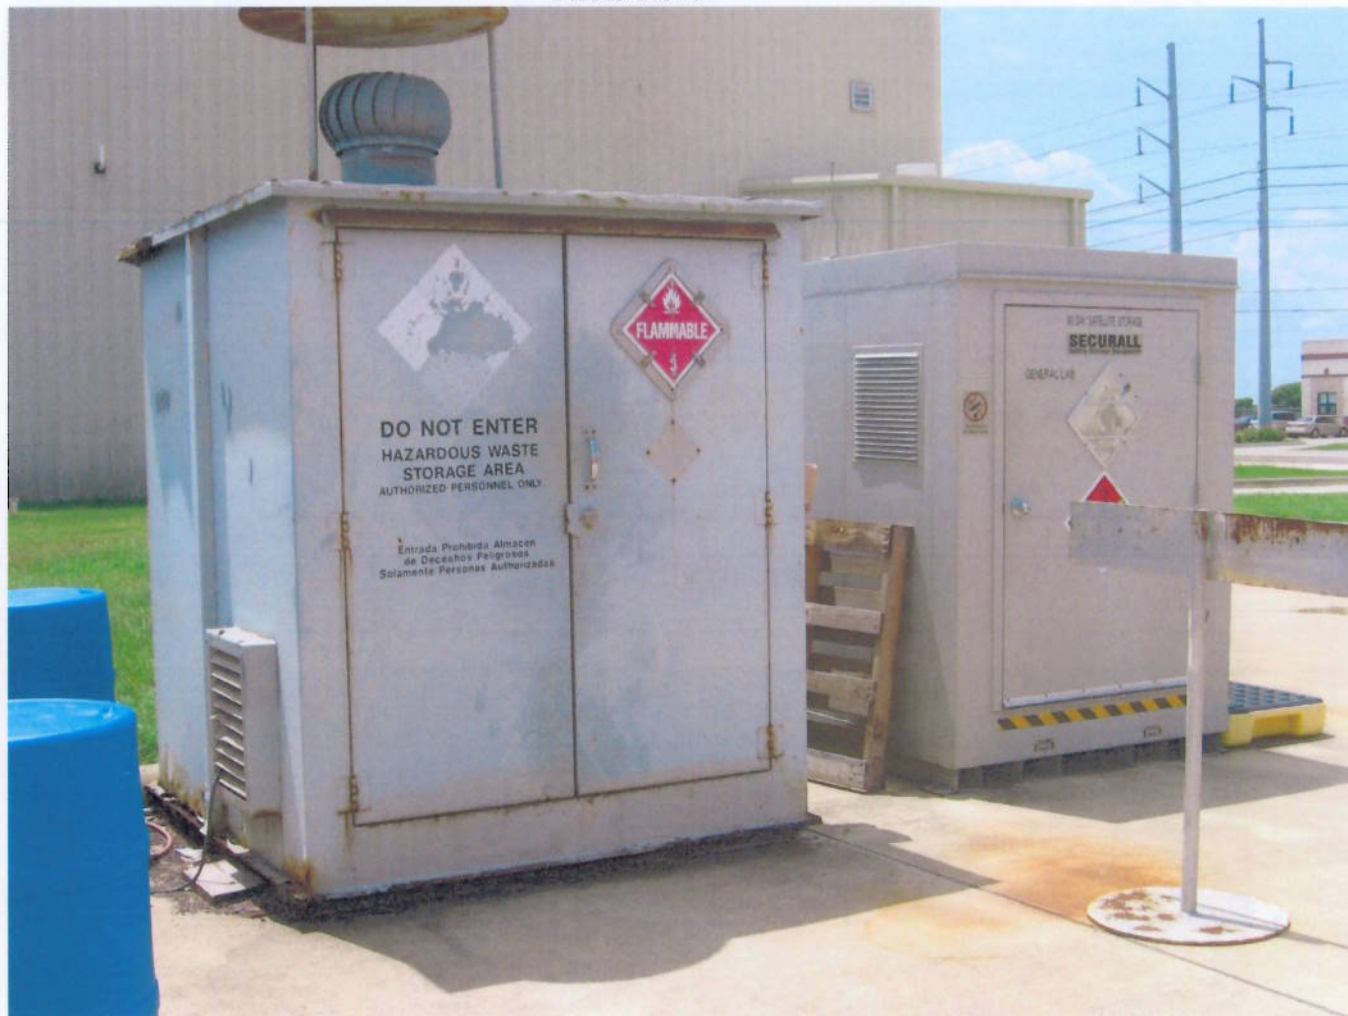
Official Photograph Log
Photo No. 5

6. SWMU 13 consists of three SAAs, one of which is for the Technical Laboratories. Formosa maintains an SAA in the general laboratory and an SAA in the research and development laboratory for storage of used chemicals and clean-out residues from analytical equipment. These areas are located under chemical hoods that have splash and air handling controls. There is also a less than 90-day Container Storage Area for the Technical Laboratories outside of the laboratories (see Attachment B, Photograph 5).

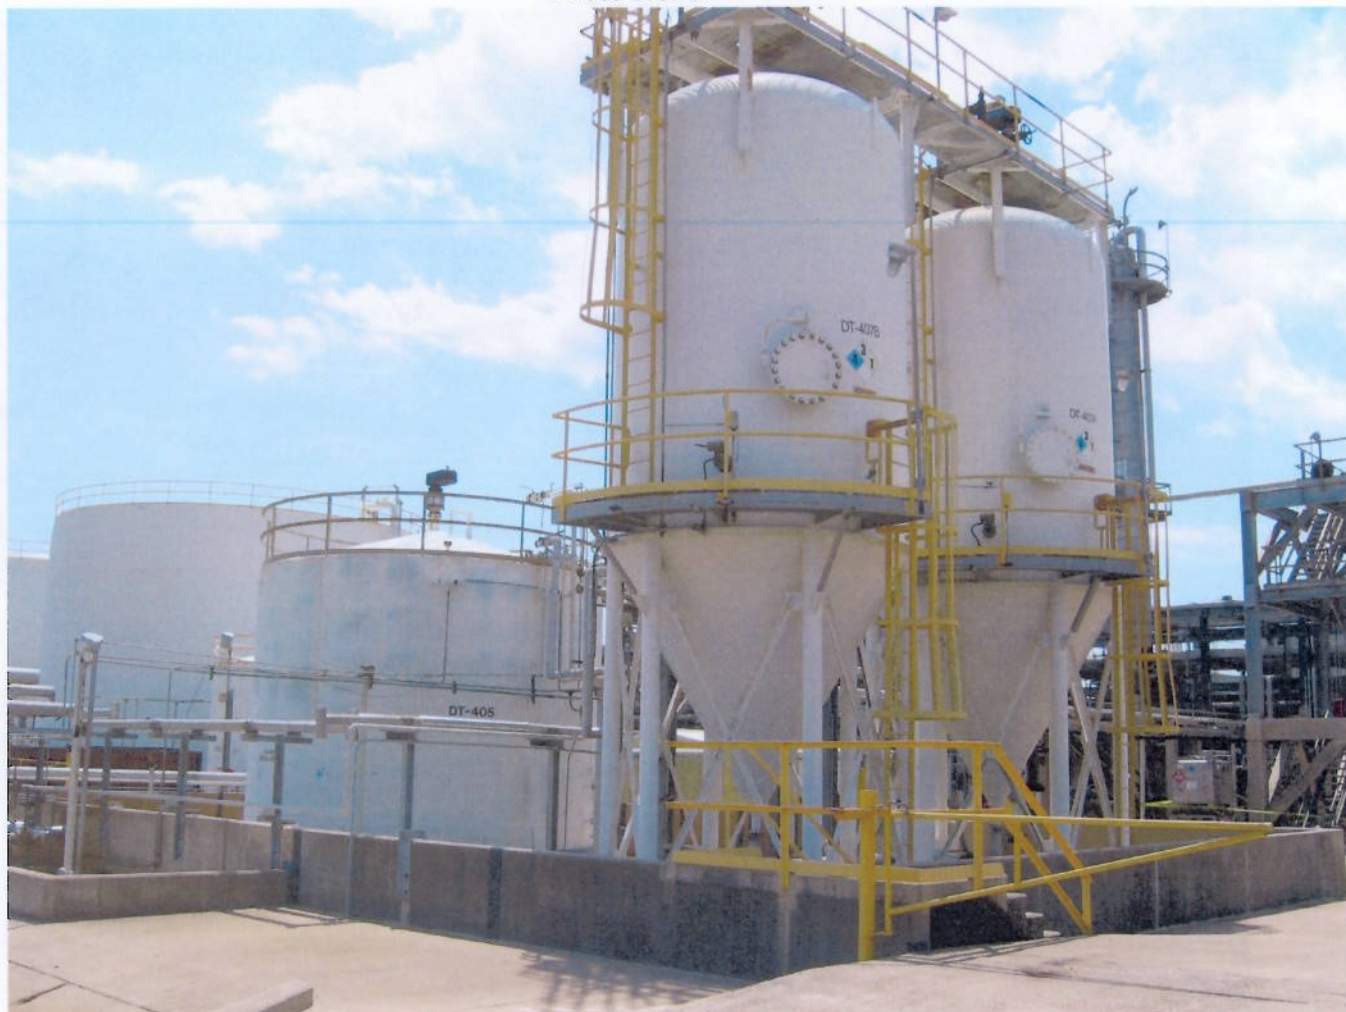
Official Photograph Log
Photo No. 6

- a. SWMU 1 is Hazardous Waste Tank DT405. This tank has not been used and was closed by TCEQ (see Attachment B, Photograph 6).
- b. SWMU 2 is Hazardous Waste Tank DT407A. This tank receives heavy ends products from the Chlor Alkali Plant; the heavy ends are sold as product to PPG in Louisiana (see Attachment B, Photograph 6).

- c. SWMU 3 is Hazardous Waste Tank DT407B. This tank receives heavy ends products from the Chlor Alkali Plant; the heavy ends are sold as product to PPG in Louisiana (see Attachment B, Photograph 6).

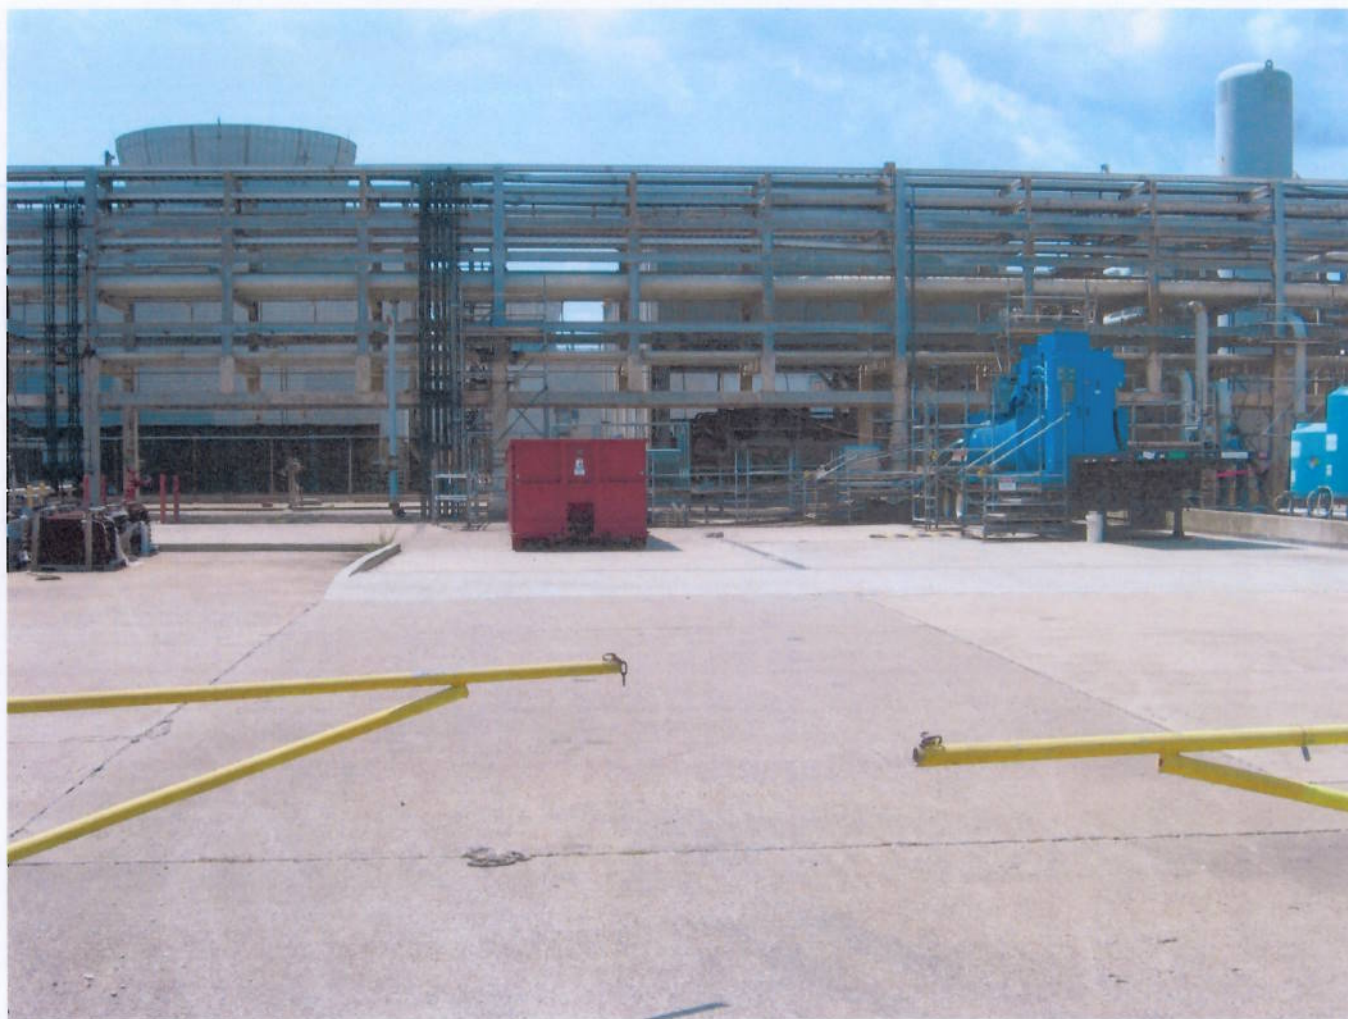
Official Photograph Log
Photo No. 7

- f. SWMU 6 is a CSA within the battery limits of the Chlor Alkali plant. The CSA is used to store roll-off boxes used for plant maintenance and repair activities. Once the roll-off boxes are full, the boxes are moved to the less than 90-day container storage yard in the pre-1991 area of the facility. At the time of inspection, there was one roll-off box containing scrap metal in the CSA (see Attachment B, Photograph 7).

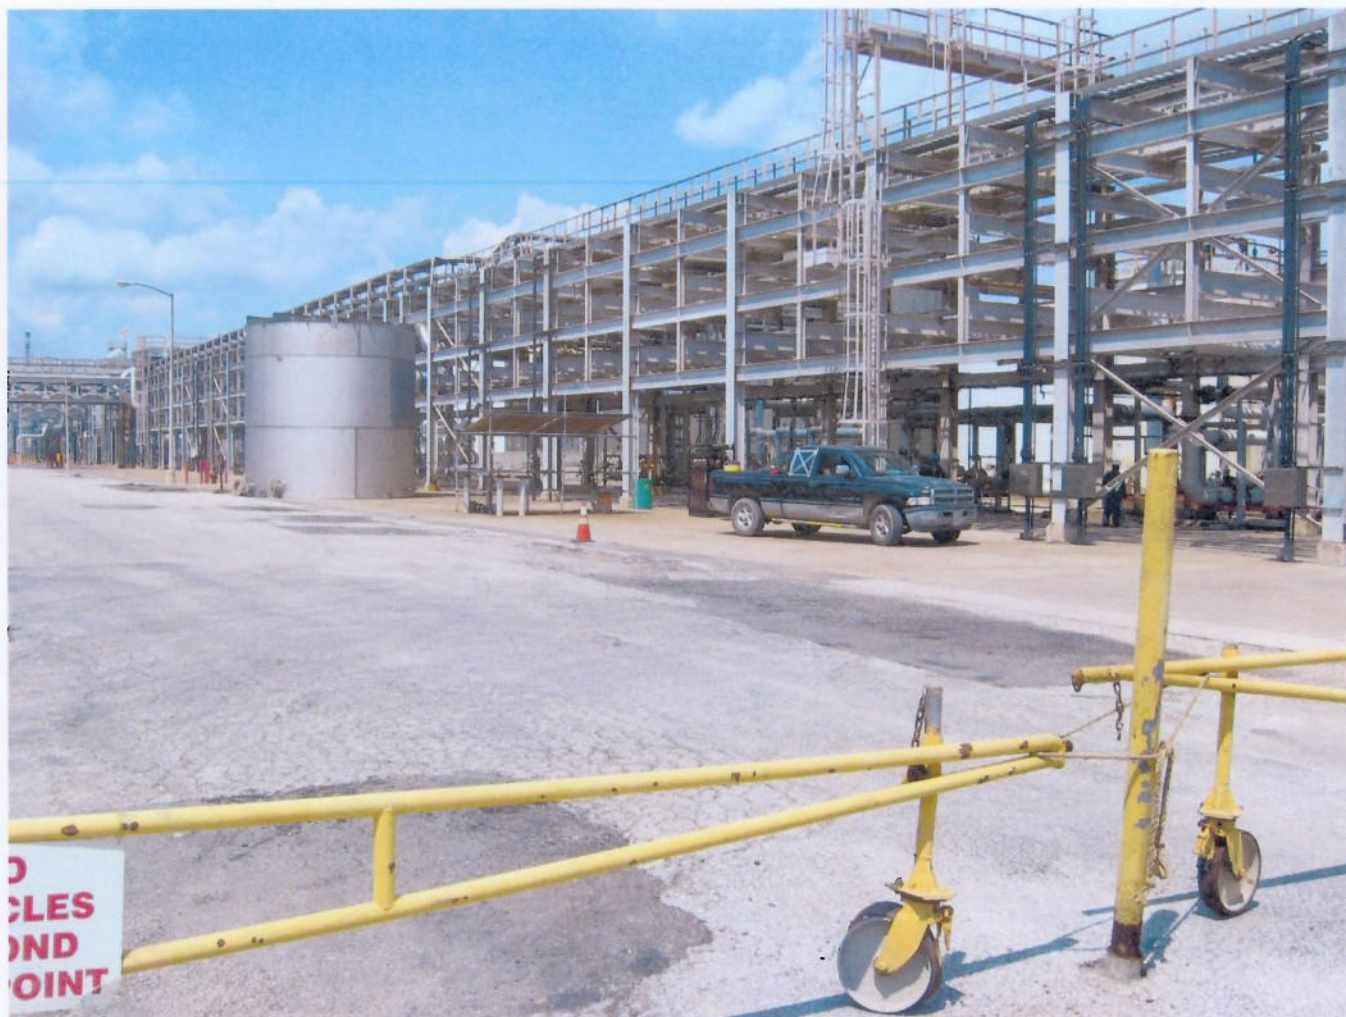
Official Photograph Log
Photo No. 8

- g. SWMU 10 is a CSA in the Chlor Alkali Plant used to contain mercury-contaminated acid wastes. The wastes were generated when Formosa determined that the sulfuric acid that they had purchased and had placed into the production line was contaminated with mercury. The fluids that had contacted the acid, the unused acid, and the process lines rinse waters were contained in the CSA prior to shipment off-site to a permitted disposal facility. At the time of the inspection, there were no containers in the CSA (see Attachment B, Photograph 8).

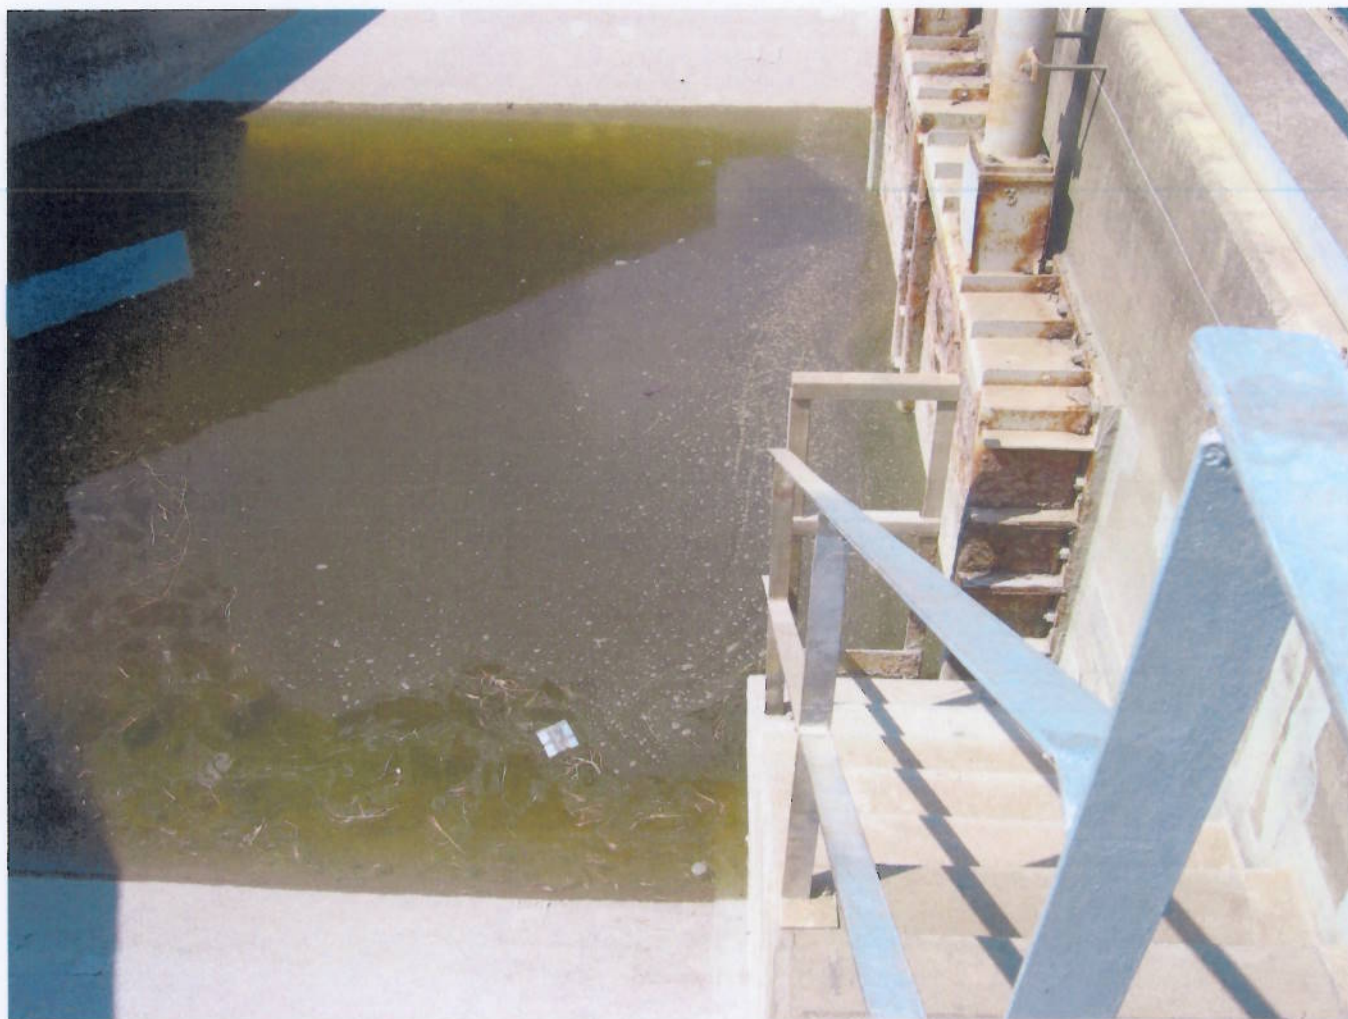
Official Photograph Log
Photo No. 9

- a. Outfall 006 is located immediately south of the CWTP and drains most of the southern end of the Expansion Area. At the time of the inspection, the stormwater outfall was cleaned of vegetative debris and solid waste (see Attachment B, Photograph 9). EPA observed minnows in the standing water above and below the outfall.

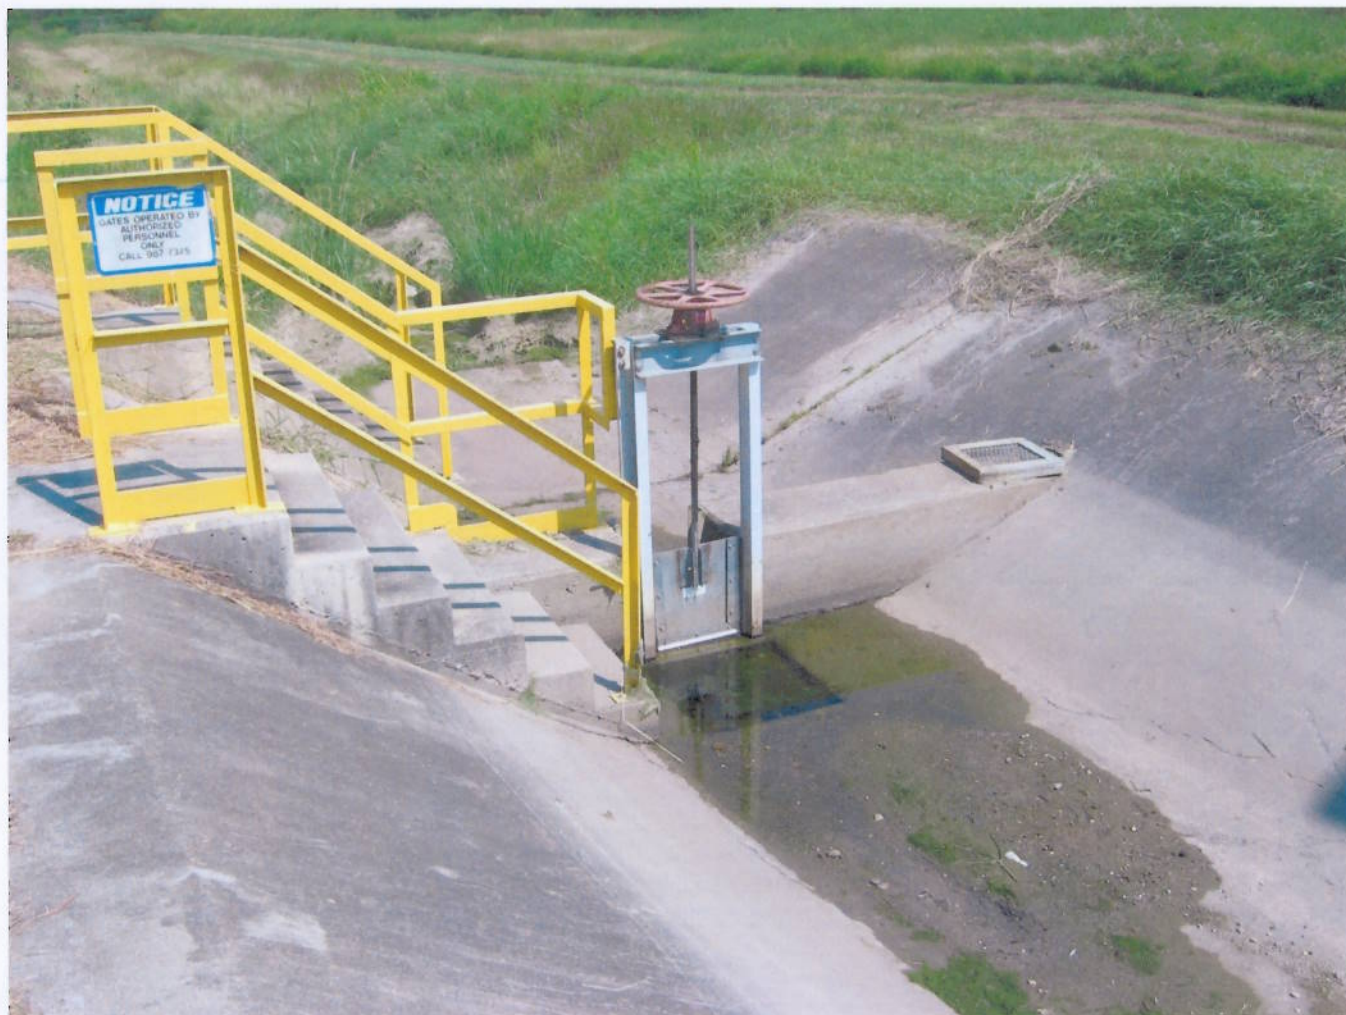
Official Photograph Log
Photo No. 10

- b. Outfall 007 is located north of the CWTP and drains around the CWTP and the Inland Traffic area. At the time of the inspection, the stormwater outfall was cleaned of vegetative debris and solid waste (see Attachment B, Photograph 10).

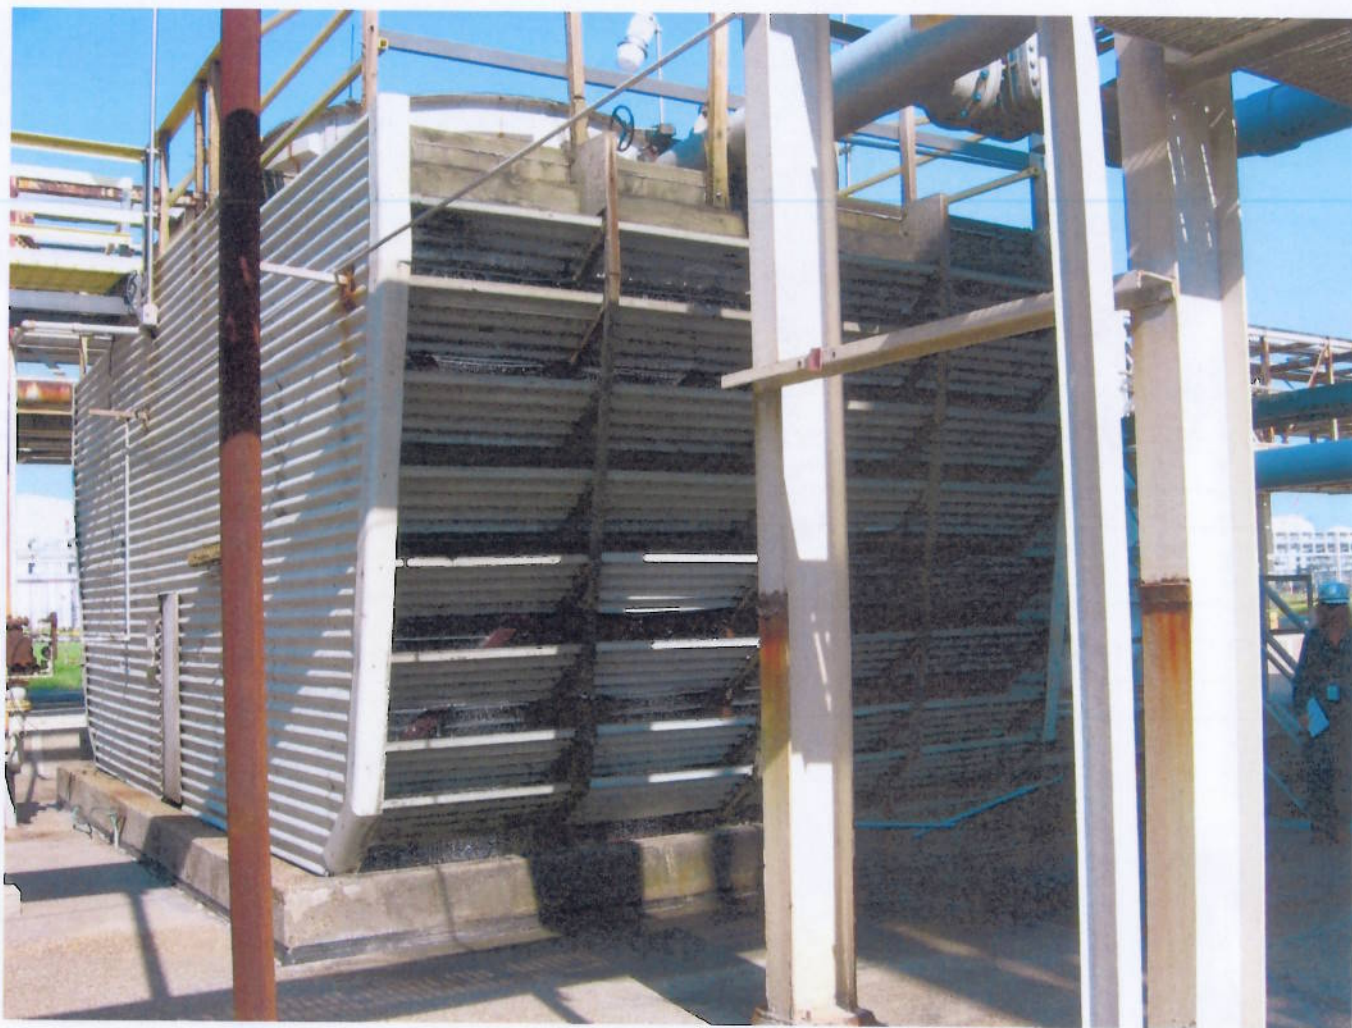
Official Photograph Log
Photo No. 11

- a. EPA inspected the brine chiller for the Chlor Alkali Plant. This area had been overflowing due to pump malfunction during EPA's 2010 inspection. At the time of the inspection, the pumps and chiller were operating without incident (see Attachment B, Photograph 11).

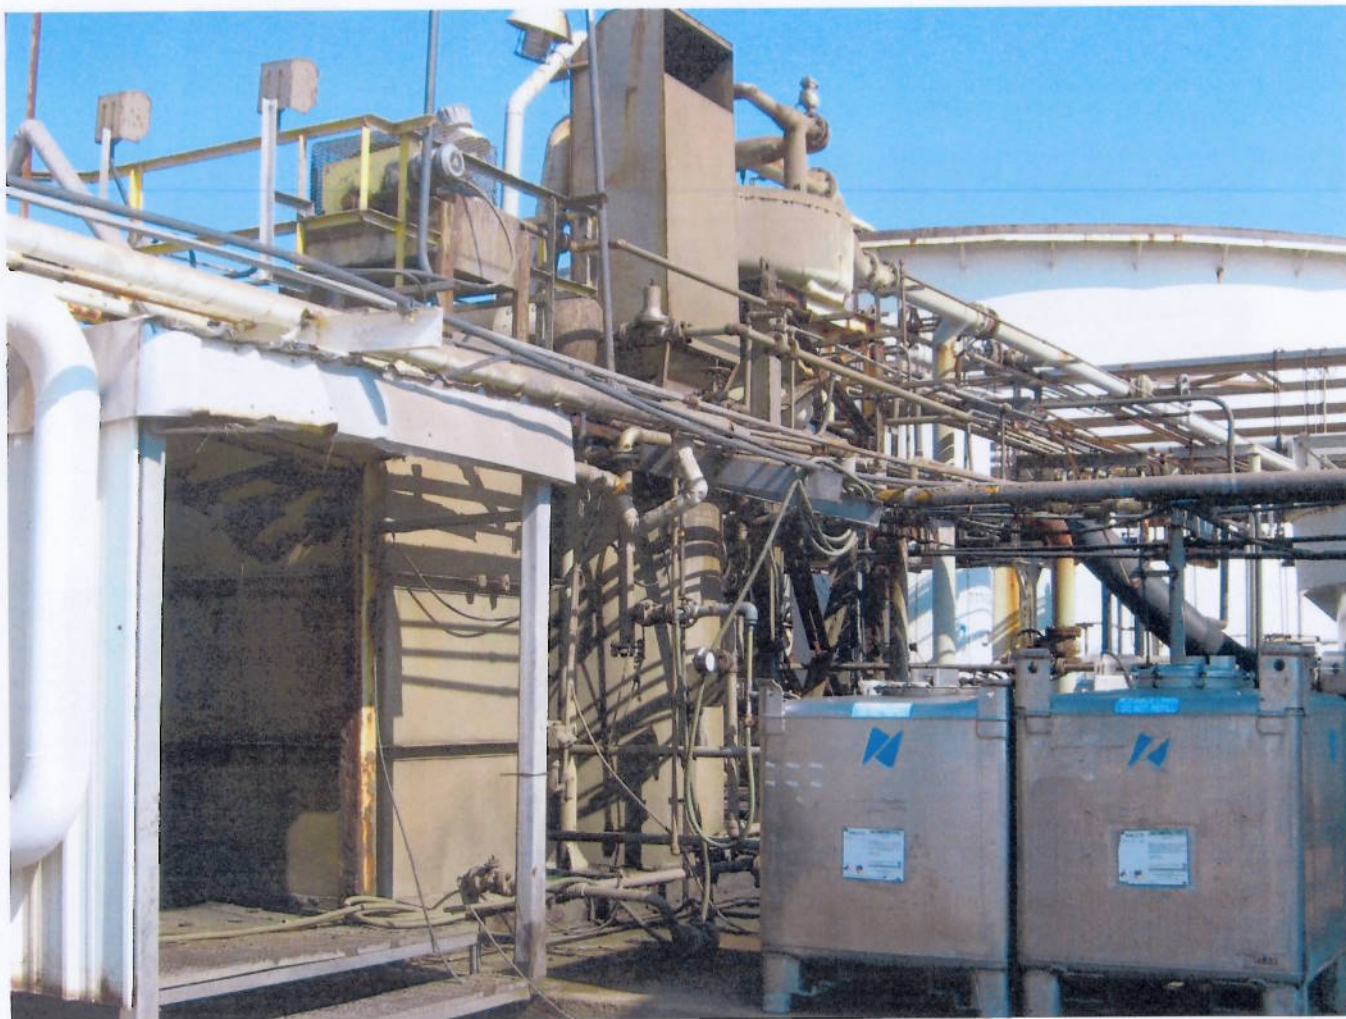
Official Photograph Log
Photo No. 12

- e. EPA inspected the copper compression unit. During the EPA inspection in 2010, this area had a discharge of copper sludge to the stormwater drainage system due to a pump failure. At the time of this inspection, the copper removal system was operating without incident (see Attachment B, Photograph 12).

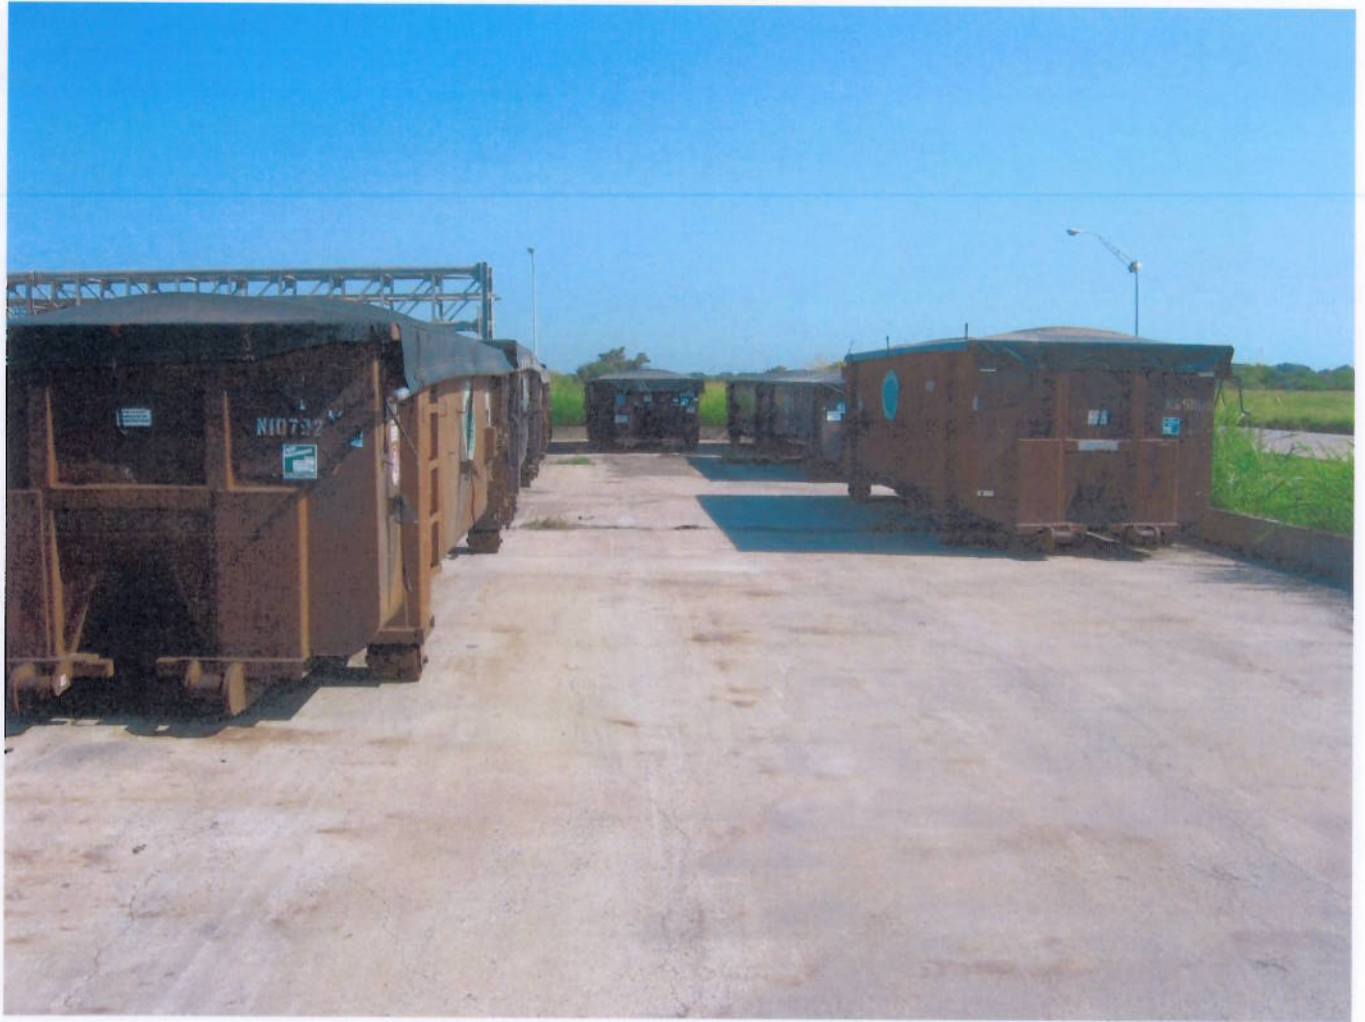
Official Photograph Log
Photo No. 13

- f. Formosa described the removal of water from the sludges generated at the CWTP in the belt press. The solids generated from the belt press are stored in roll-off boxes (see Attachment B, Photograph 13), sampled for waste classification, and disposed as Class II nonhazardous waste.

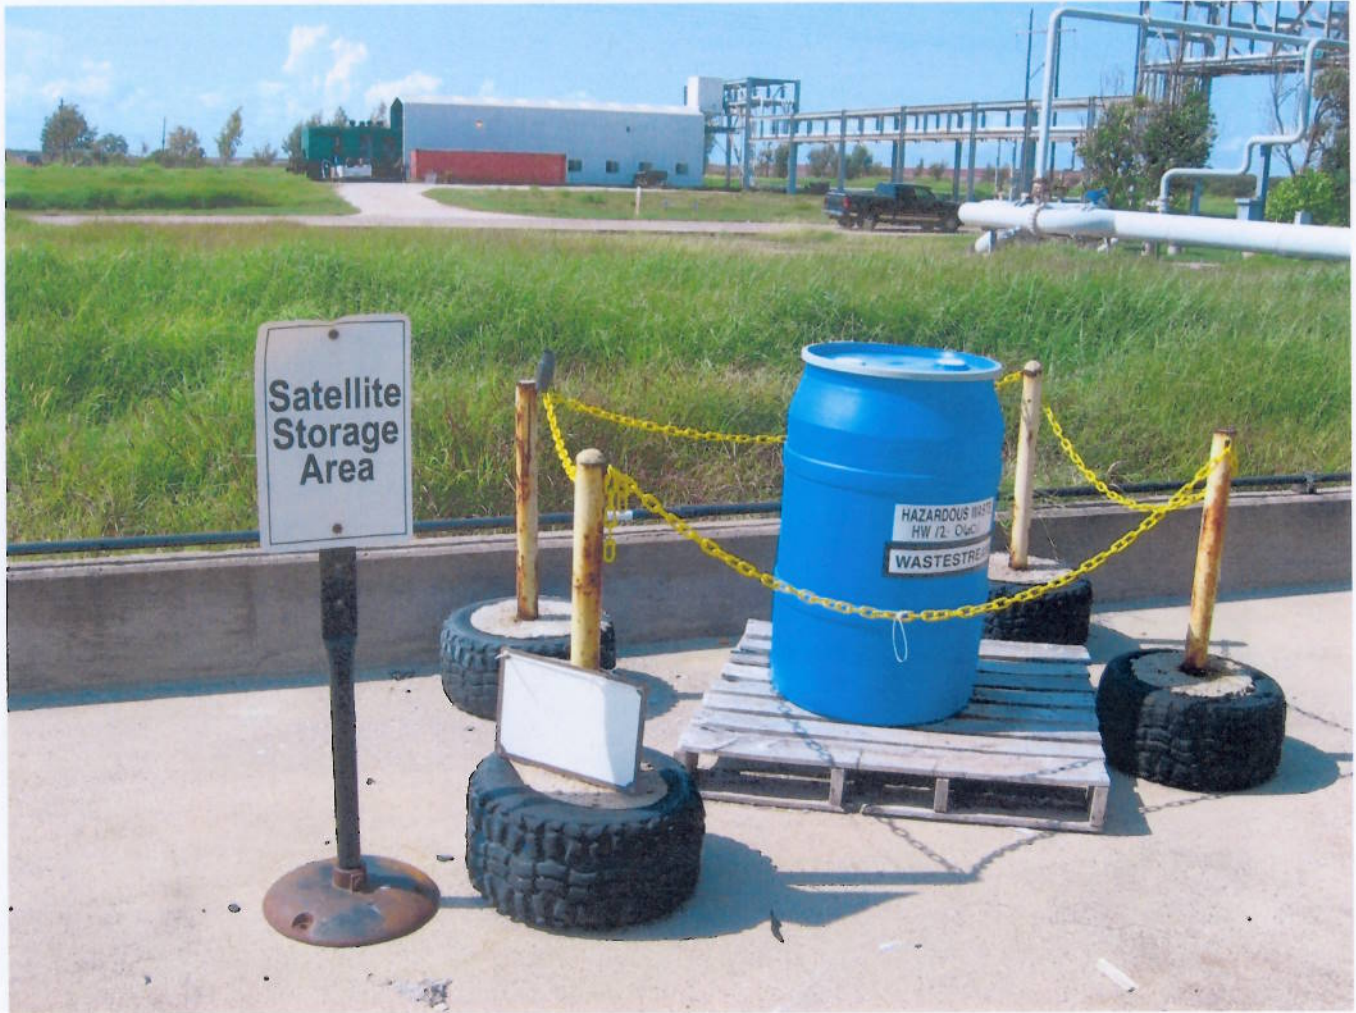
Photo No. 14

- h. Immediately southwest of the mixing box, Formosa has established a satellite accumulation area for collection of hazardous waste sludges (see Attachment B, Photograph 14) generated when sludge from the mixing box is removed. The sludges are listed hazardous waste from the groundwater treatment system.

| Subject: Hazardous waste SAA at CWTP | | |
